MISCELLANEOUS PAPER NO. 4-850

# EVALUATION OF GUIDE RAIL IN CONJUNCTION WITH KAISER AND HARVEY LANDING MAT (AM2)

October 1966

U. S. Army Engineer Waterways Experiment Station  
CORPS OF ENGINEERS  
Vicksburg, Mississippi

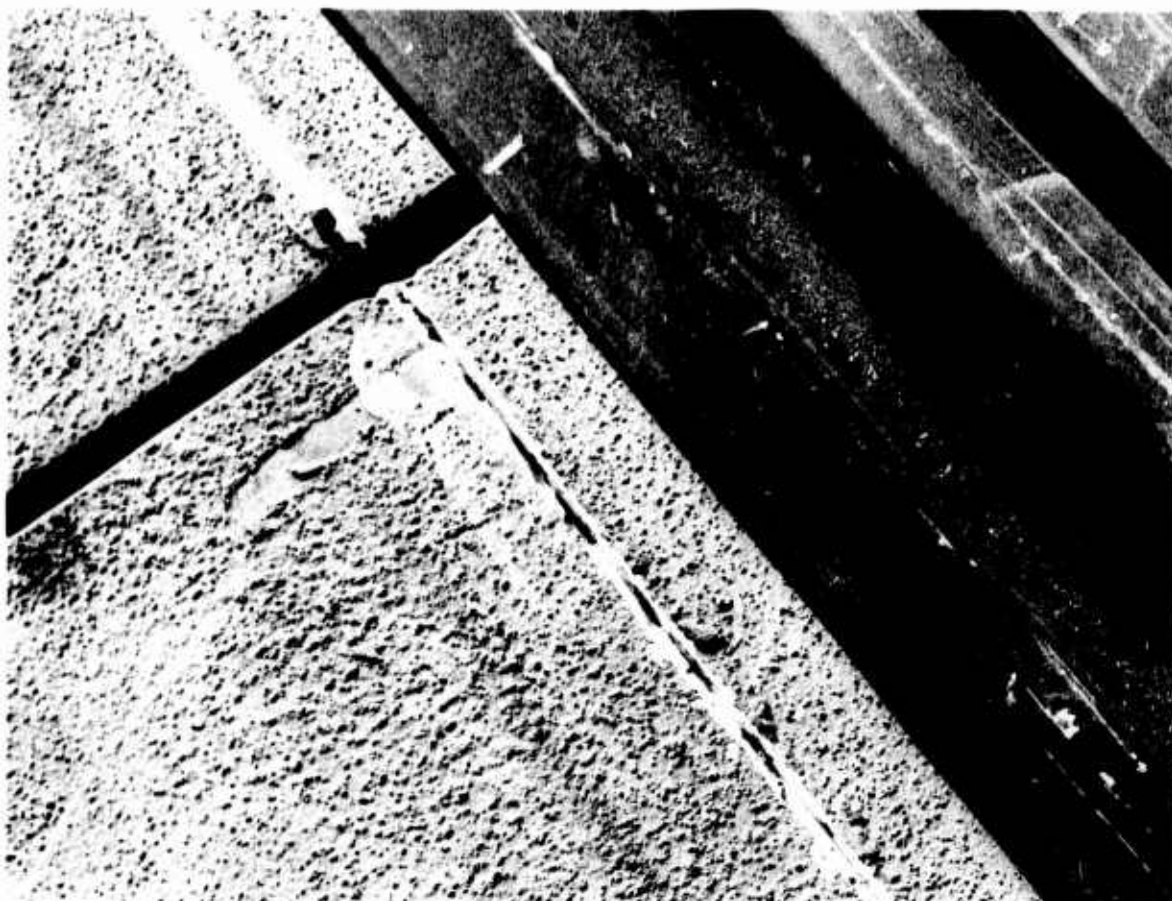
25. Visual observations. After the first few passes of the load wheel, small hairline cracks were noted on several mat planks adjacent to the guide rail where the AM2 end connector was welded to the plank extrusion. By the end of 11 passes, the cracks were quite noticeable in three planks of item 4 (the low-strength clay item), and by 20 passes, the end-connector joints had completely separated on four test planks due to weld failure, and eight other joints were badly cracked. A close-up view of two of the failed joints is shown in fig. 7. A general view of item 4 at the end of 20 passes is shown in photograph 3, which shows that the general appearance of the mat and guide rail at the end of 20 passes was fairly good; the mat surface remained smooth and the bodies of the planks were not damaged. However, as the load passed over the failed joints, the planks deflected downward below the sheared end connector which was still connected to the guide rail. This resulted in a tire hazard; therefore, item 4 was considered unserviceable at the end of 20 passes.

Fig. 7. Close-up of end-joint failure, lane 1, item 4

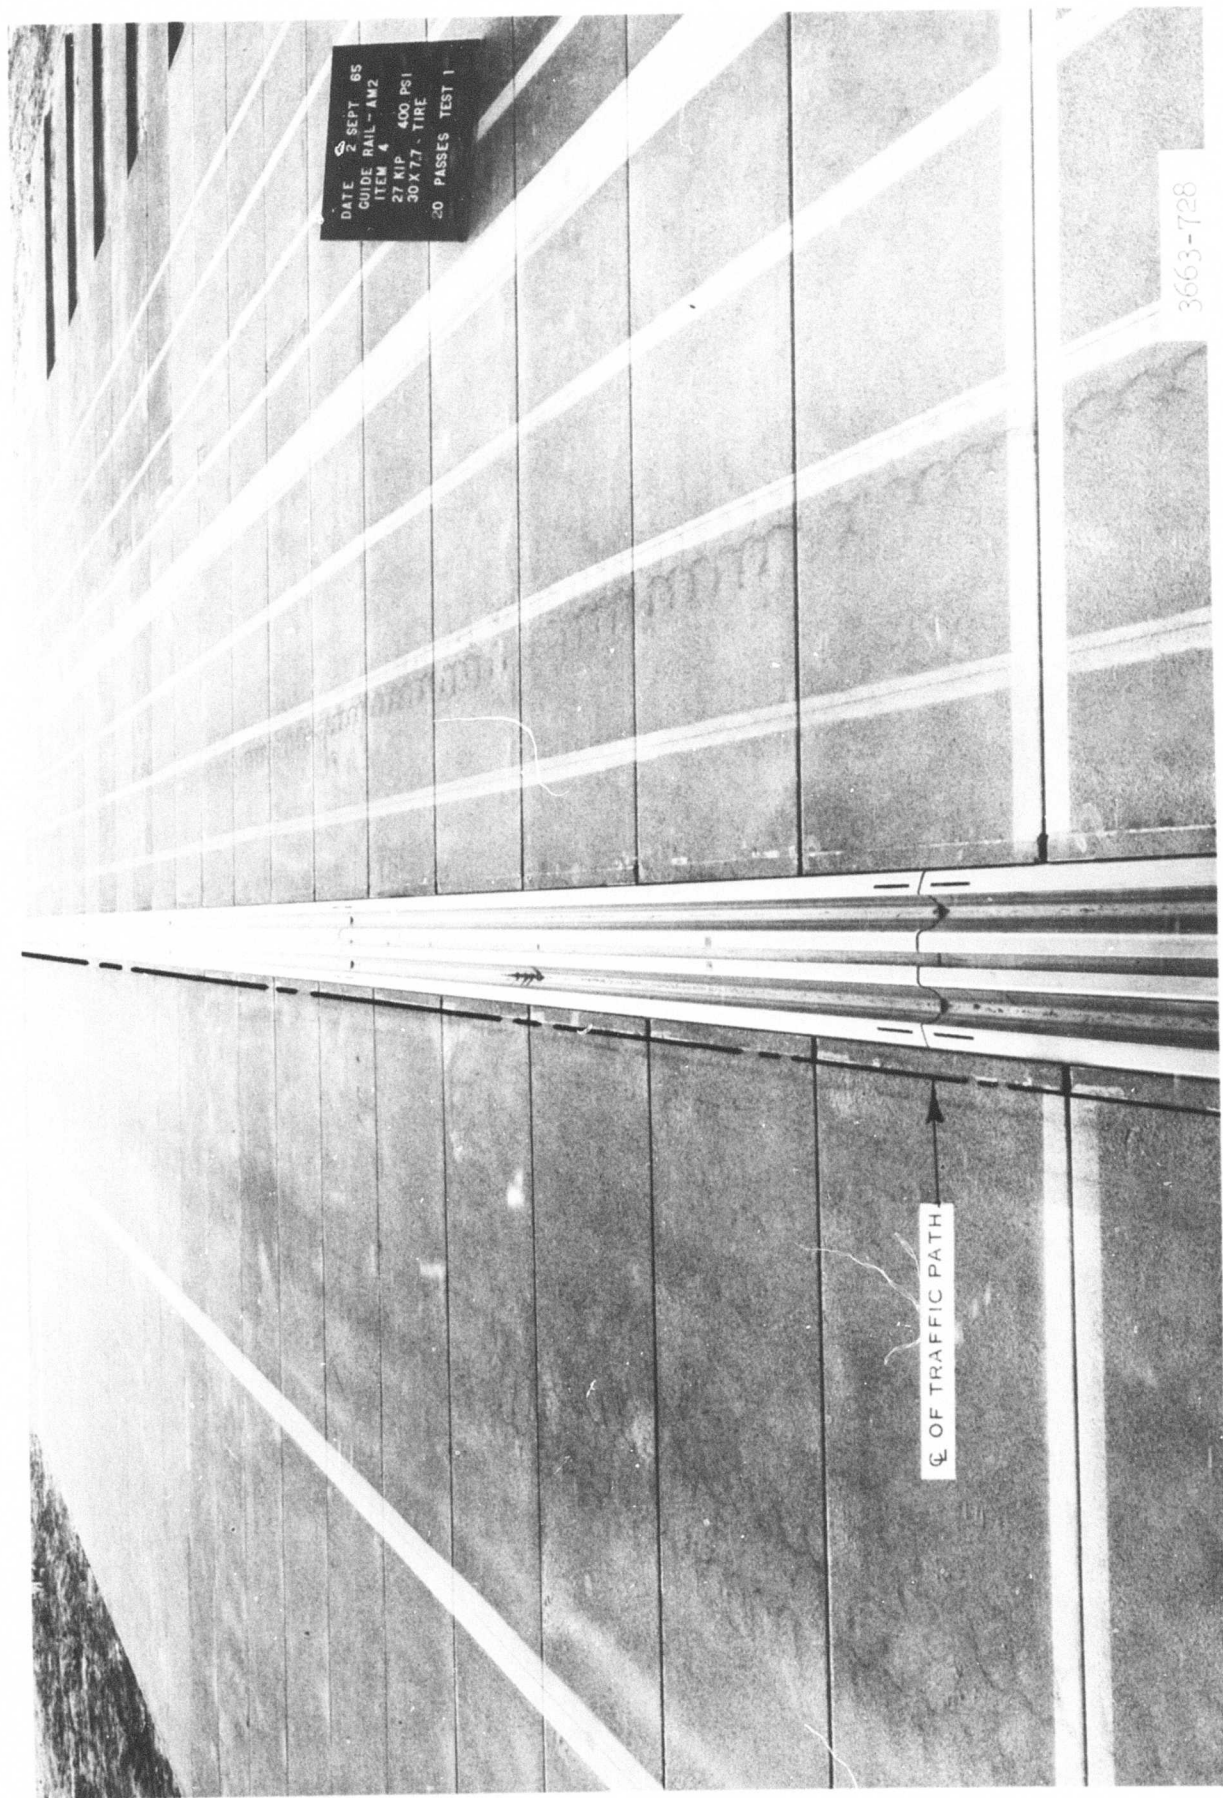
Photograph 3. Test item 4, lane 1, after 20 passes of load wheel

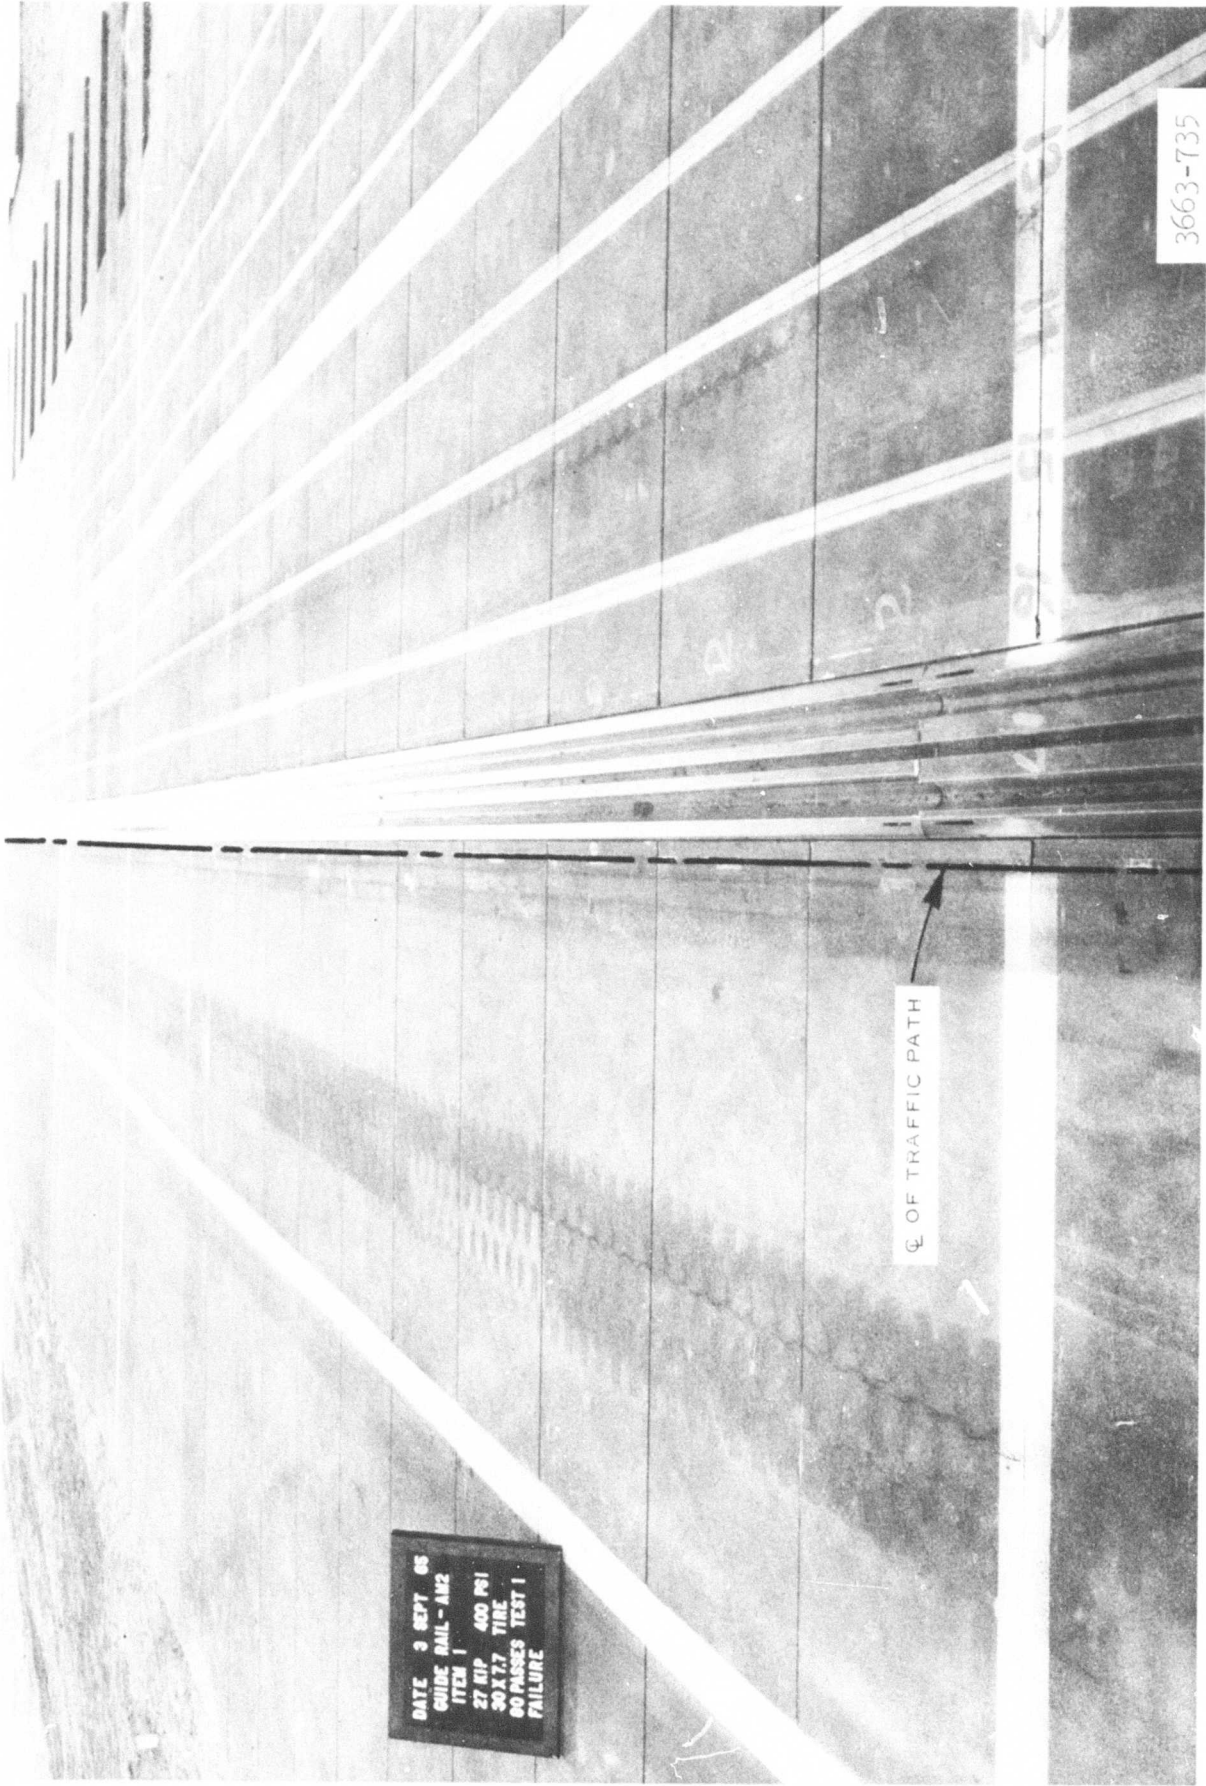
27. As traffic continued, weld failures developed quite rapidly in items 1, 2, and 3. By the end of 70 passes, four end joints had completely separated in item 3. At this point the item was considered failed. However, traffic was continued to 80 passes, resulting in the complete separation of eight joints. At this stage of traffic, six joints in item 1 (sand subgrade) and three joints in item 2 (high-strength clay subgrade) had failed. Traffic was continued on item 2 to 100 passes, at which time the end connectors of five additional planks separated, making a total of eight failed joints. At this stage, the entire test lane, with the exception of the Harvey and Kaiser mats in item 4, was considered unserviceable. General views of test items 1, 2, and 3 at failure are shown in photographs 4, 5, and 6, respectively. All mat failures were of the same

Photograph 4. Test item 1, lane 1, after 100 passes of load wheel

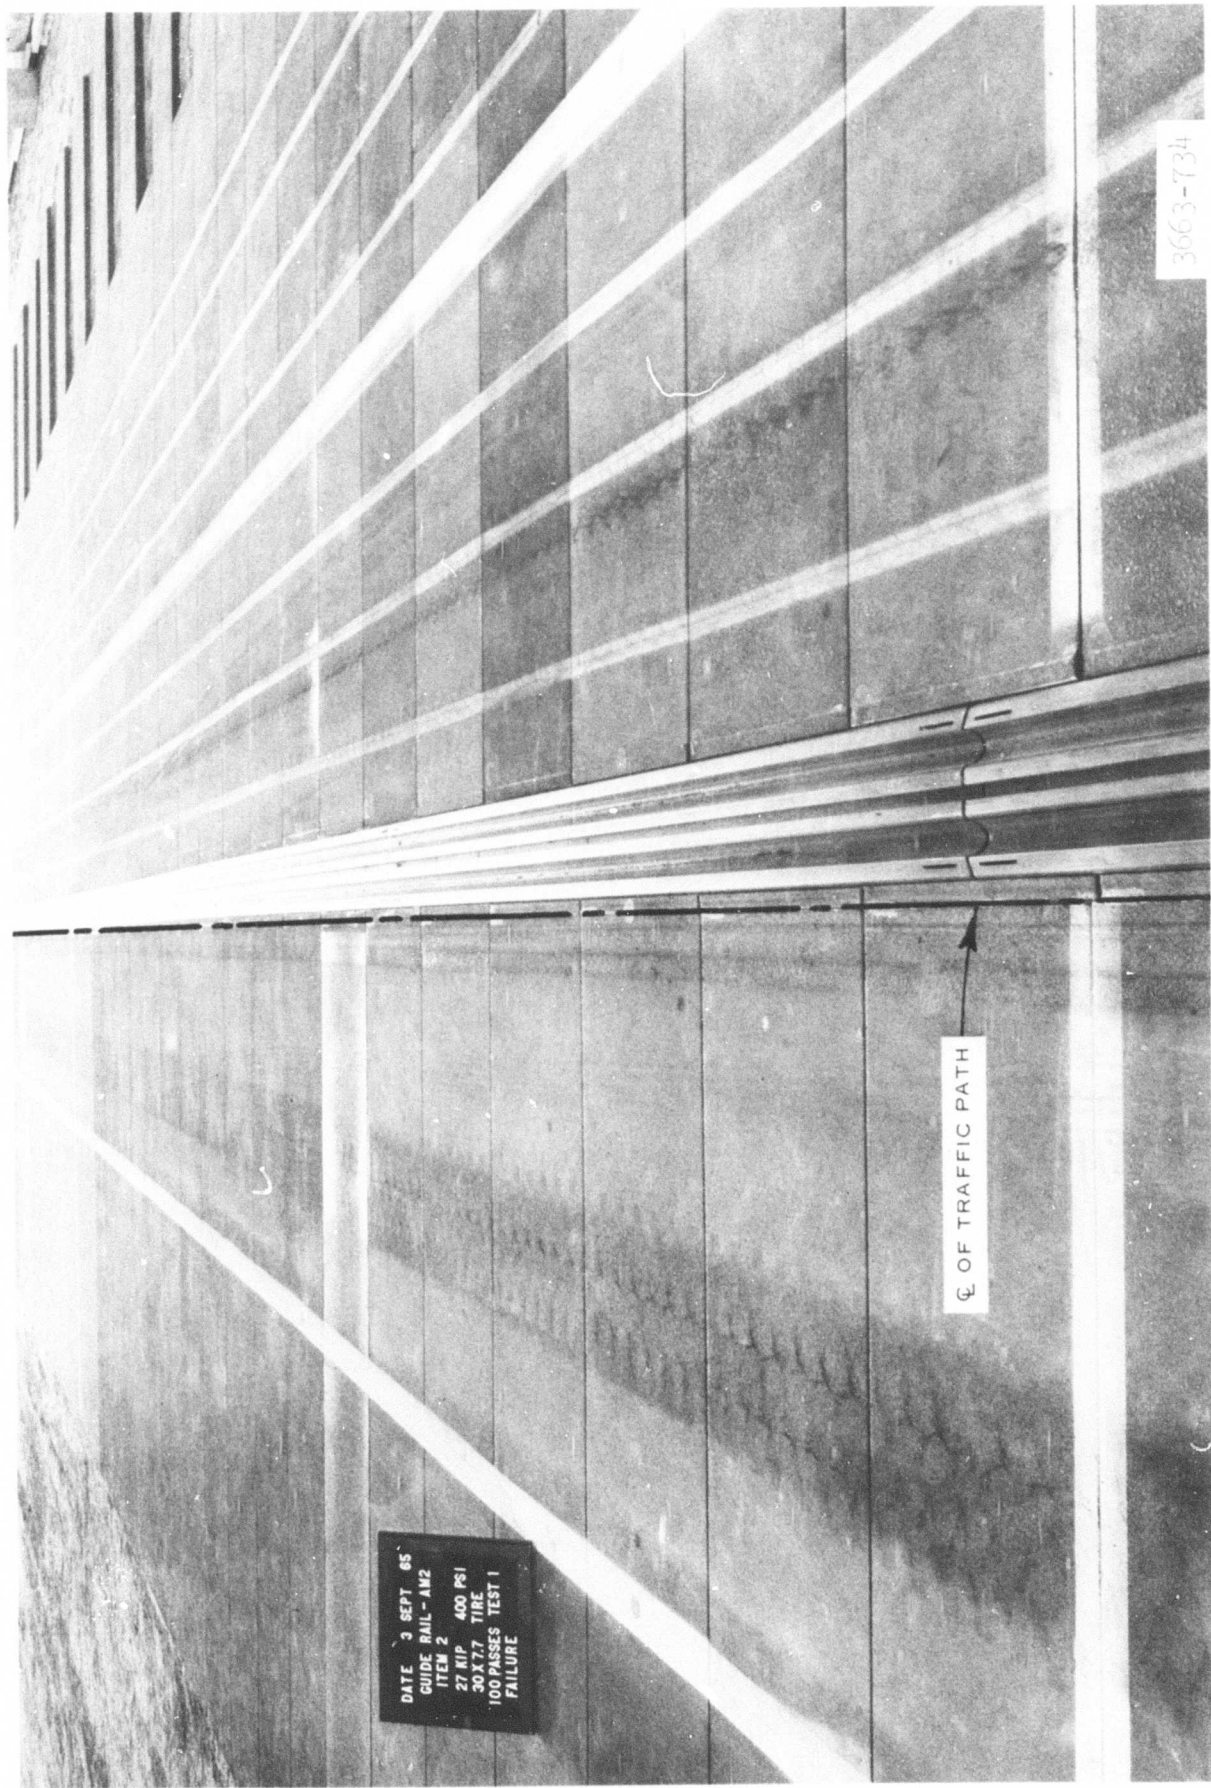
Photograph 5. Test item 2, lane 1, after 100 passes of load wheel

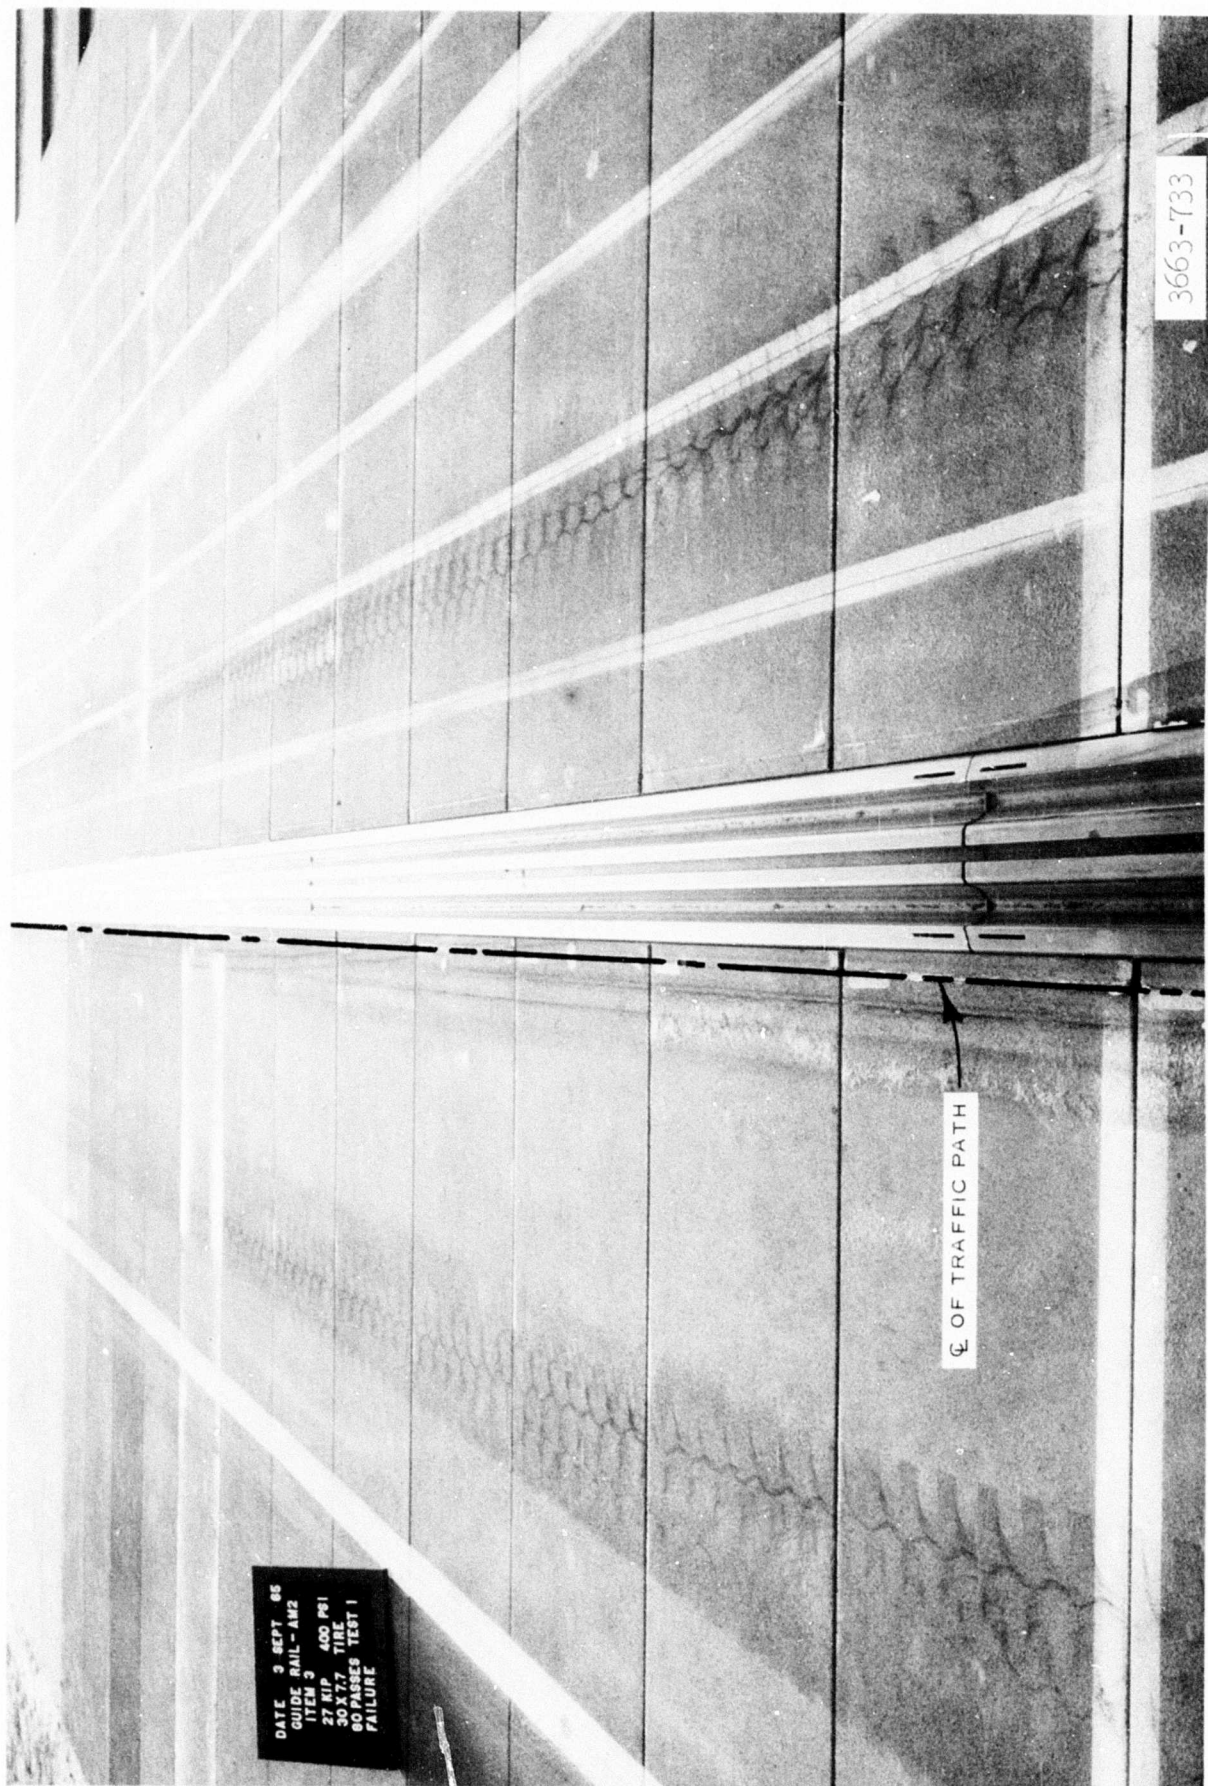
Photograph 6. Test item 3, lane 1, after 80 passes of load wheel

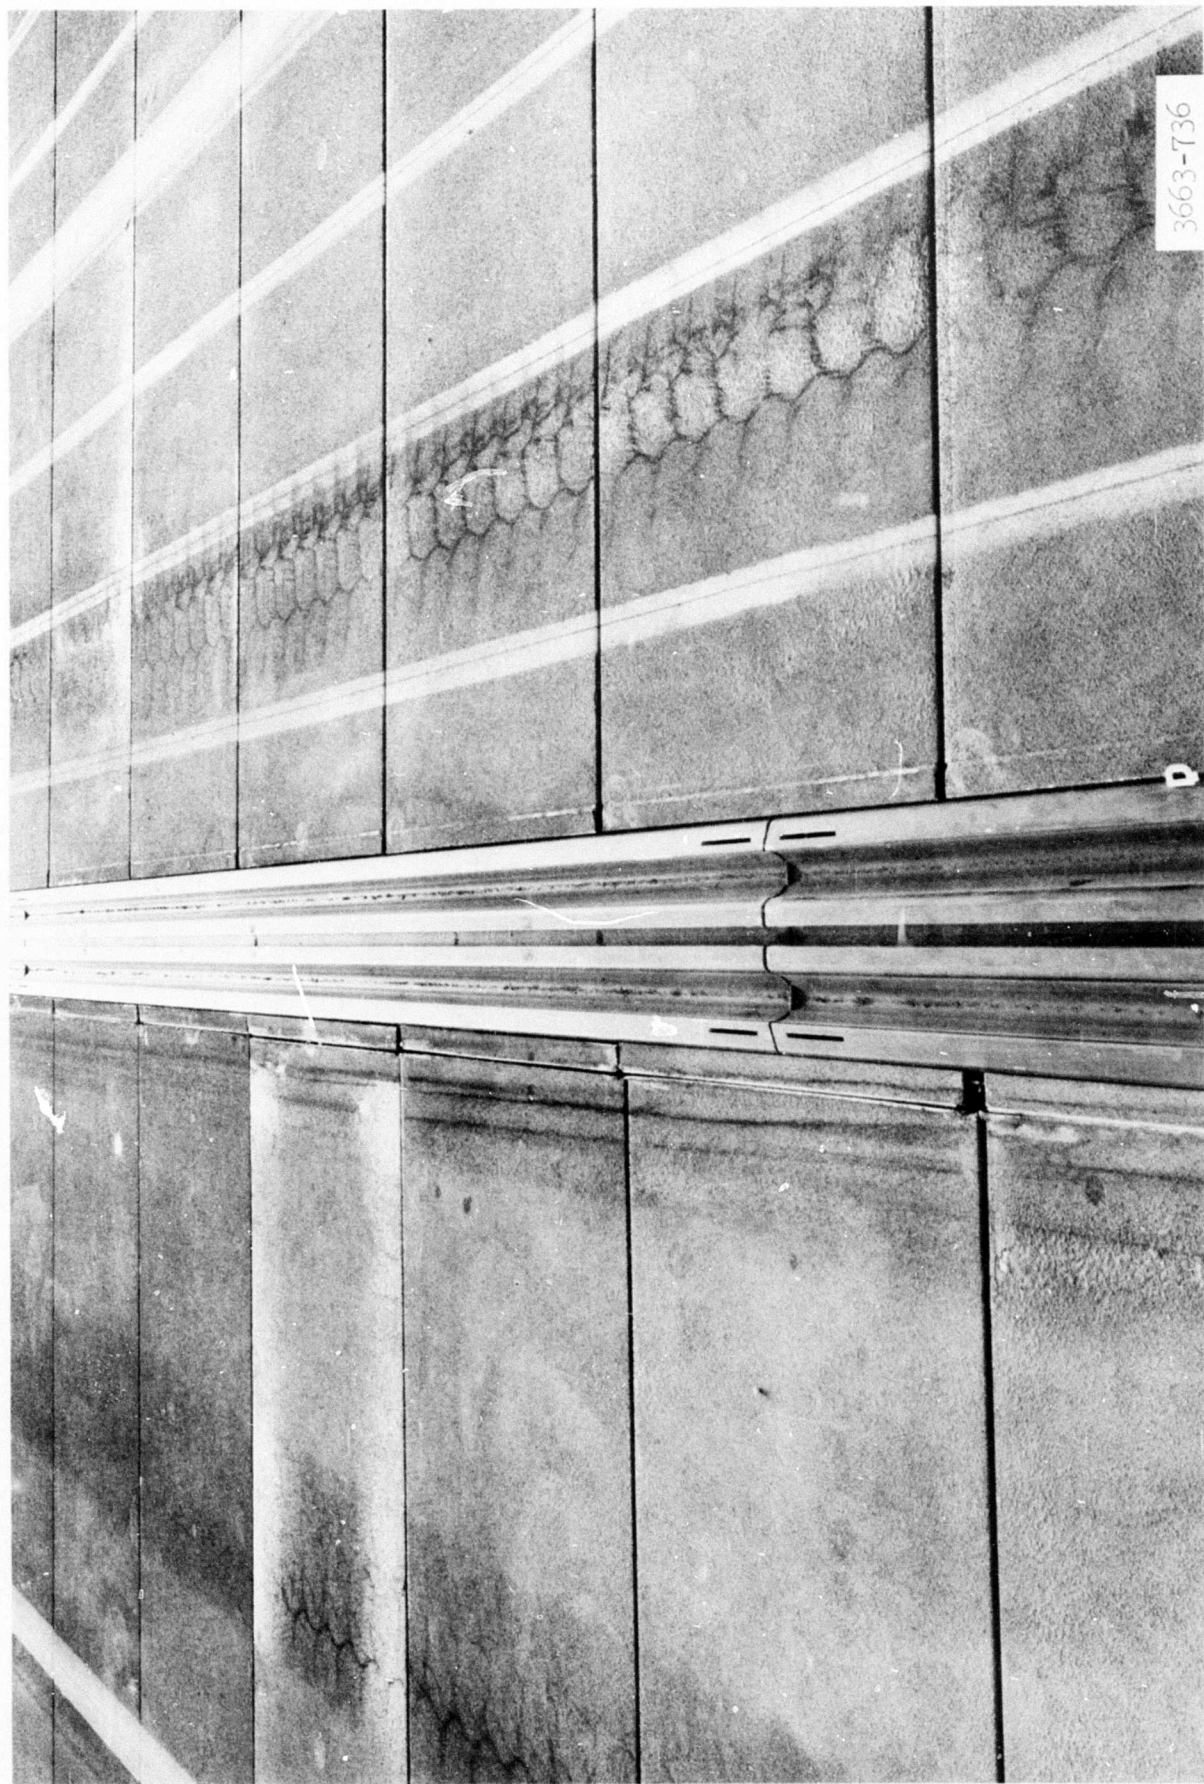
type and were caused by separation of end joints from the body of the mat planks at the weld seams. A close-up of joint failures in test item 3 is shown in photograph 7.

Photograph 7. Close-up of end-joint failures, lane 1, item 3

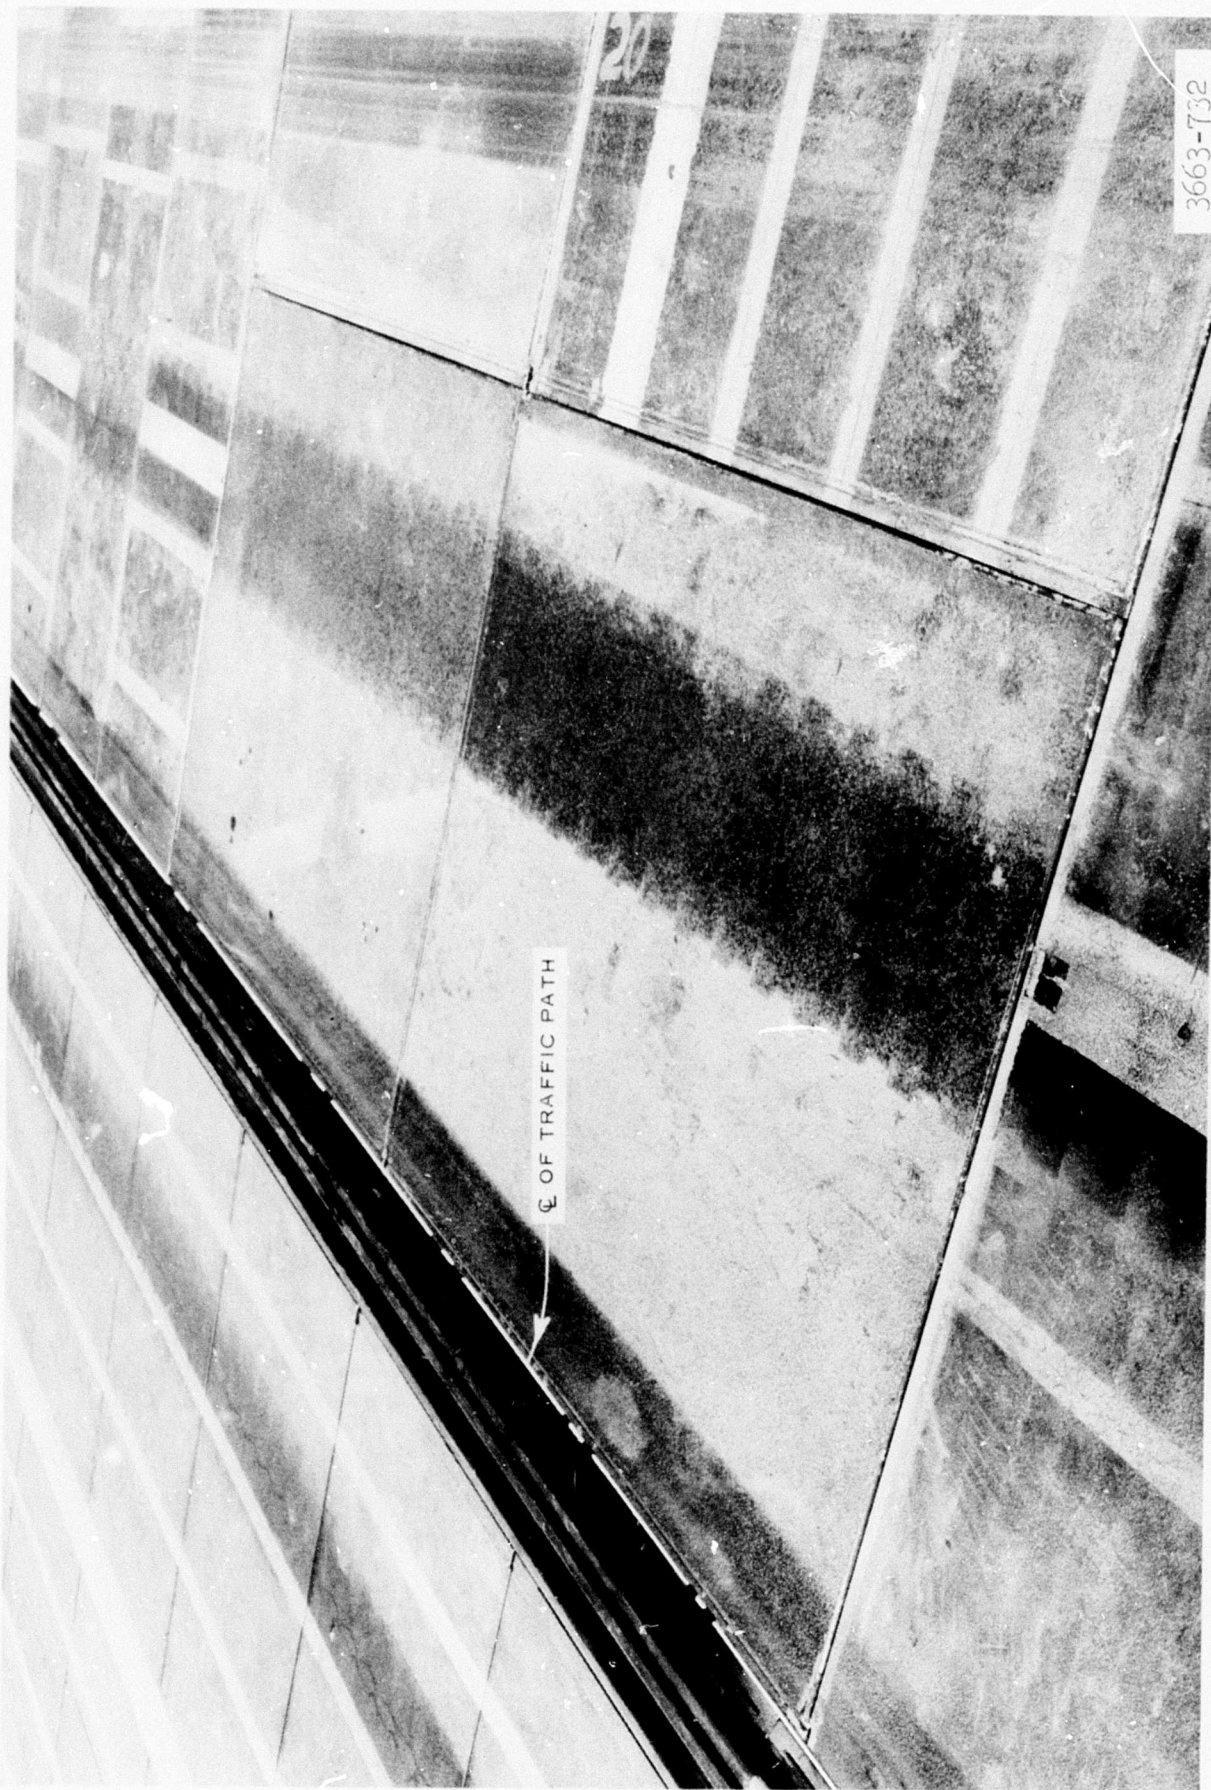
28. Traffic was continued for a total of 100 passes on the Harvey AM2 and Kaiser 4- by 4-ft mats, which were placed in item 4 after the failure of the Kaiser AM2 at 20 passes. These mats withstood the 100 passes of traffic with no evidence of mat distress, as indicated in photograph 8.

Photograph 8. Kaiser 4- by 4-ft aluminum honeycomb mat and Harvey modified AM2 in item 4, lane 1, after 100 passes

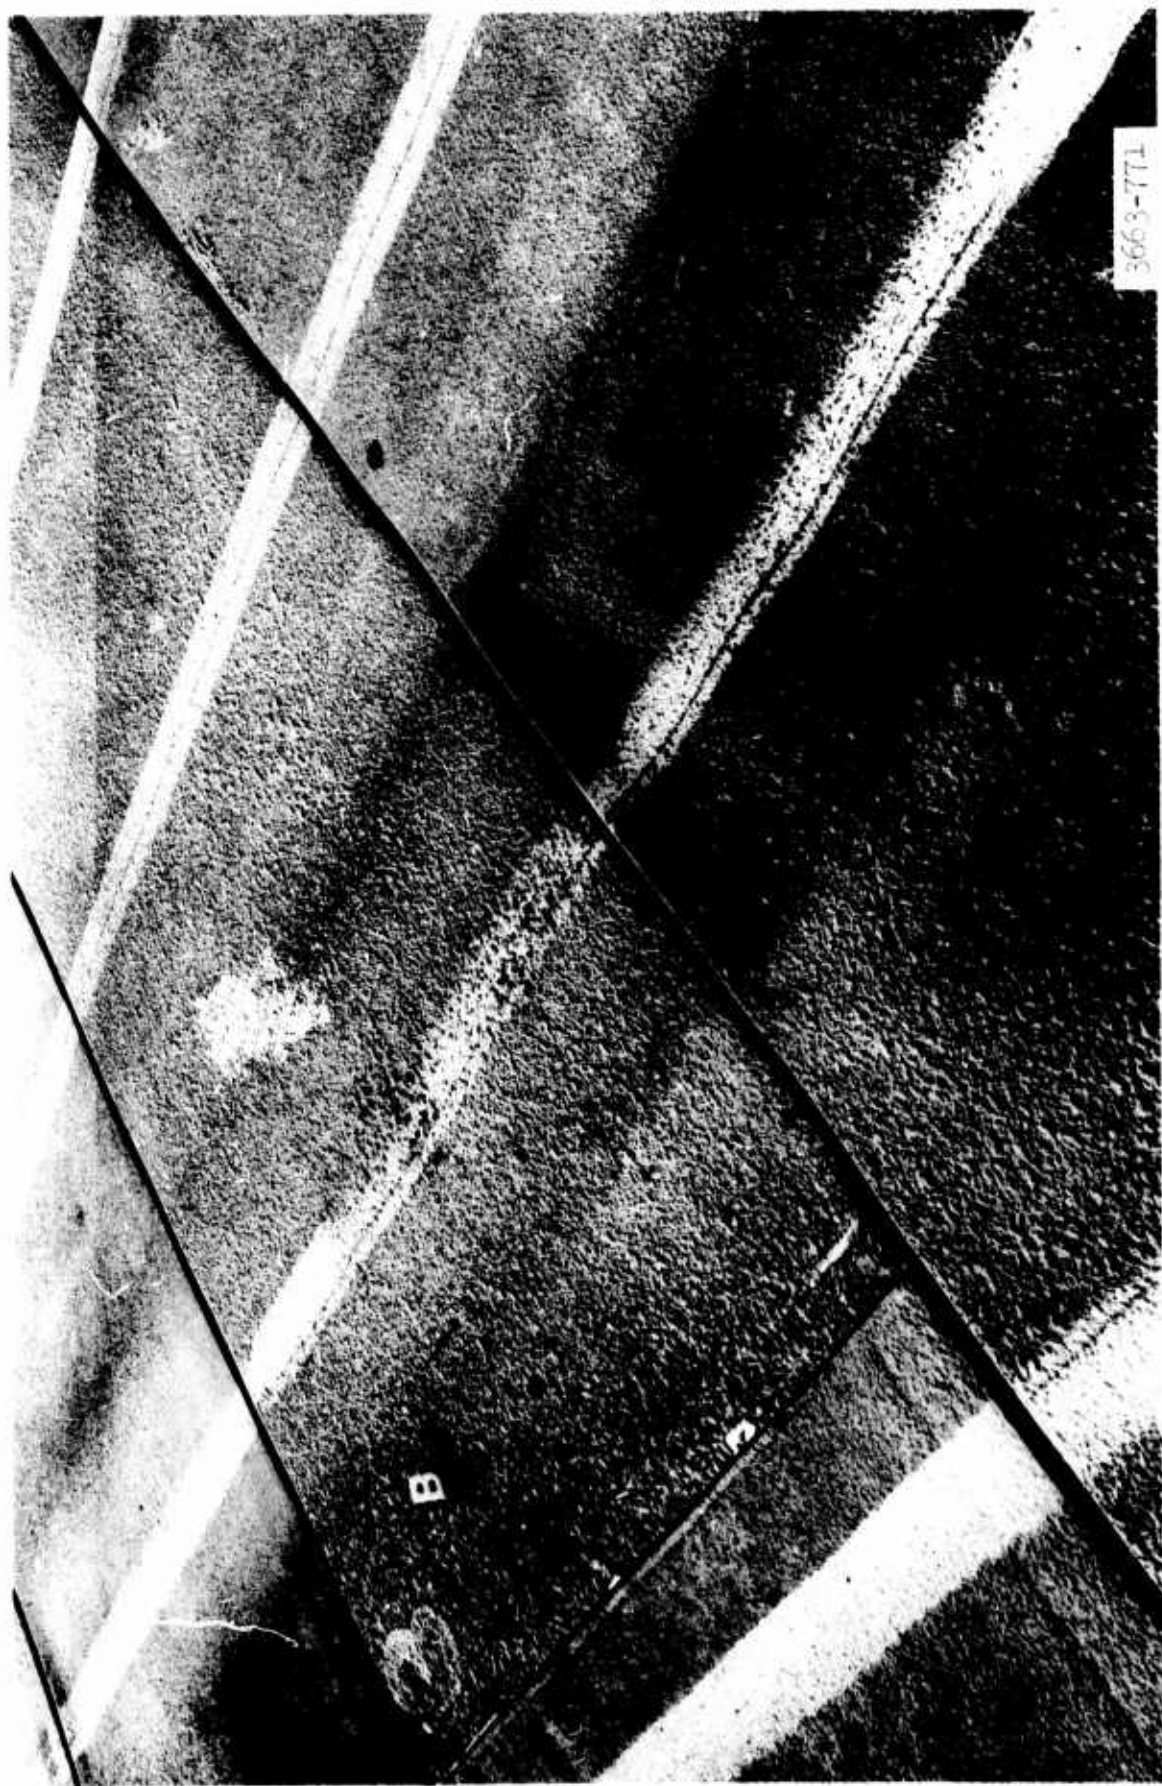
33. The first evidence of distress in the body of the mat planks was also noted at about 1000 passes of the load wheel. The distress was evidenced by depressions or dished areas on the surface of the mat planks, which normally developed first on the female edge of the plank, as indicated in photograph 11. This depression was an indication of structural failure within the mat core. As traffic was continued to a total of 1600 passes, the core failures developed quite rapidly in all test items, especially in items 1 and 4. By the end of 1600 passes, the riding surface was quite rough. In addition to the core failure, a number of weld cracks developed at the end joint 1.5 ft west of the center line of the traffic path, with two joints in item 4 completely separating. One of the weld failures is shown in fig. 8. A general view of the test lane at the completion of 1600 passes of traffic is shown in photograph 12. A close-up view showing the condition of the mat in test item 4 is shown in photograph 13. After removal of the mat from the test section, several planks were cut to determine the extent of core failures. Fig. 9 shows a

Photograph 11. Dish in mat plank indicating core failure

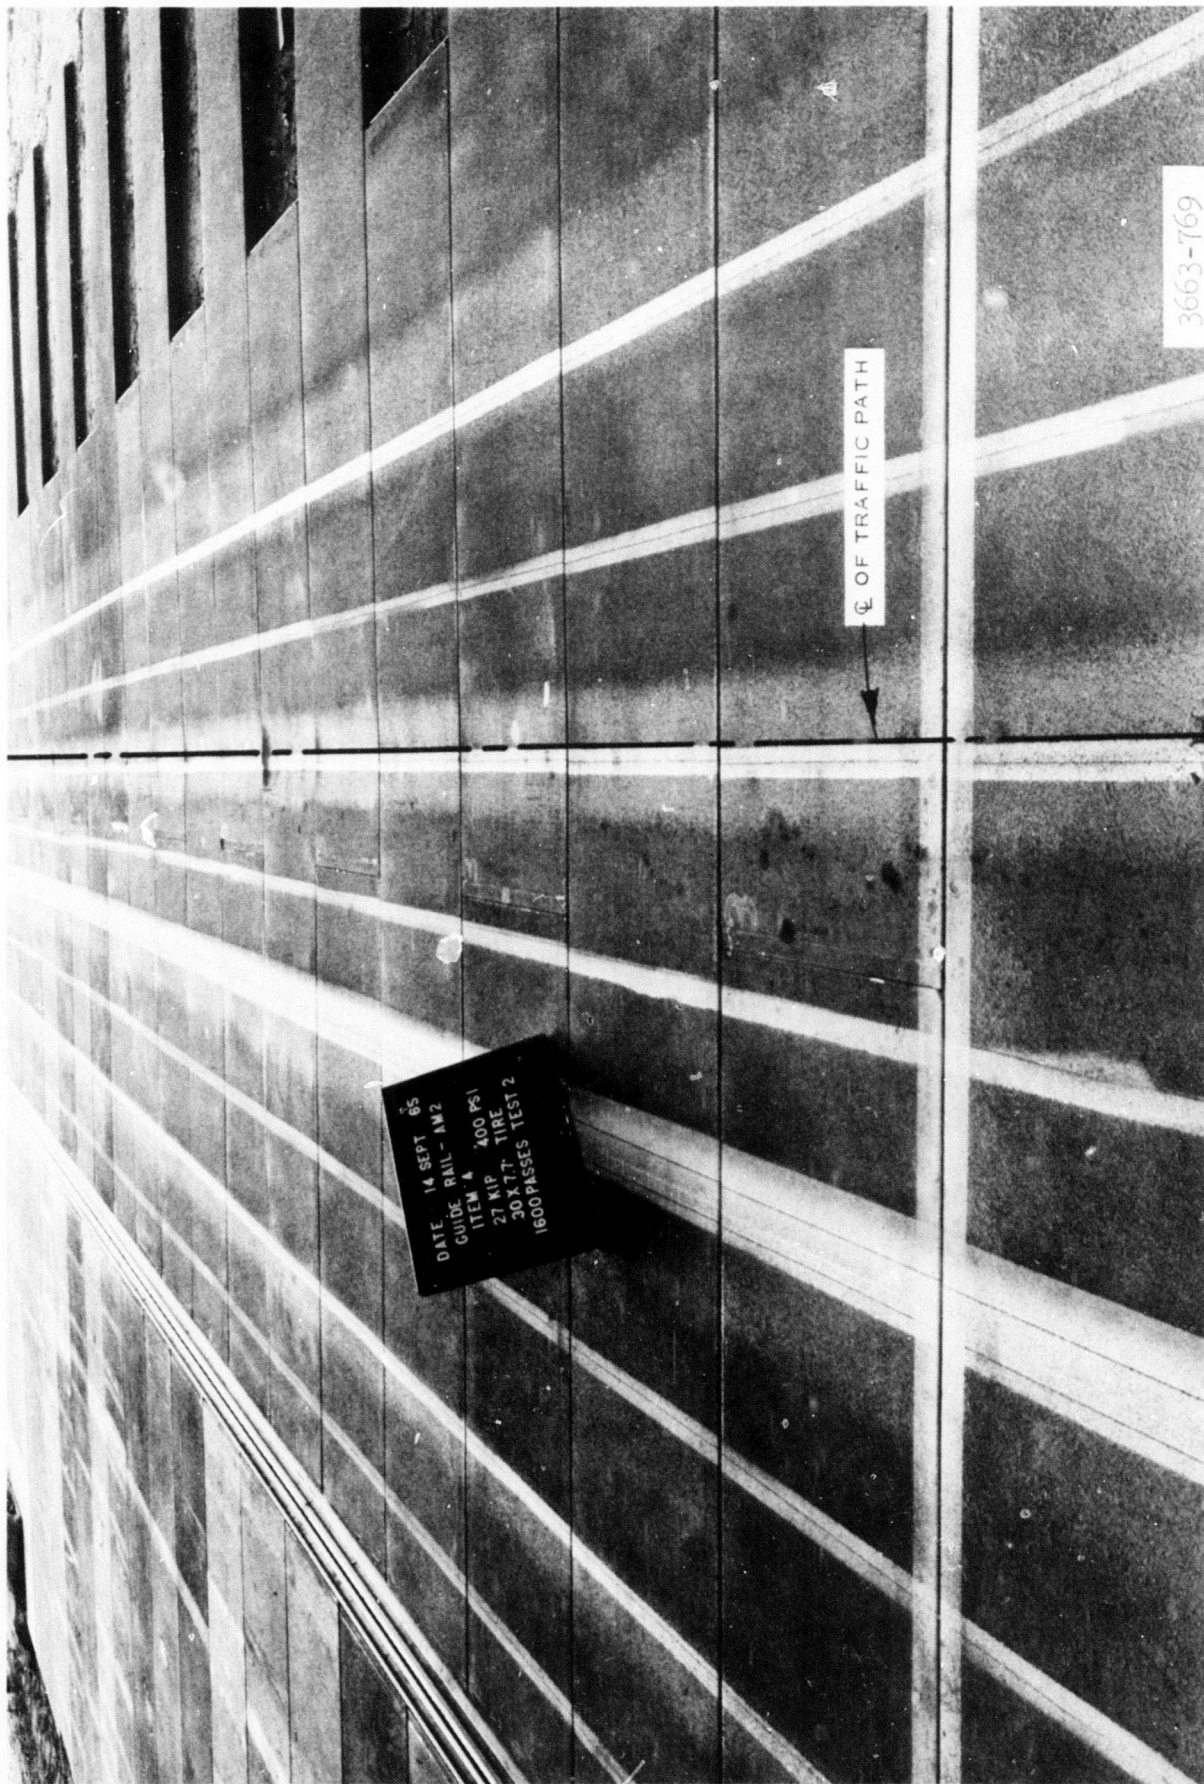
Photograph 13. Close-up of mat in item 4, lane 2, after 1600 passes of load wheel
